## CAVITY WALL TIE FAILURE

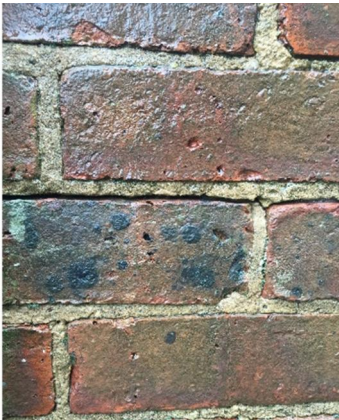
The wall tie is essential to cavity construction and is used to connect the inner load-bearing wall to the outer weather protective elevation. Cavity wall ties effectively transfer the stability of the inner skin of a wall to the outer skin. Wall ties are now mainly manufactured from stainless steel or similar materials due to their corrosion resistant properties. Earlier ties were mainly constructed in mild or galvanised steel, the fish-tail tie being the most common. Galvanised steel wire ties were used from the mid-nineteenth century although these have also been found to be very prone to corrosion.
